INSPECTION OF EXISTING SYSTEM

CITY OF SEATTLE'S EAST []

MARGINAL WAY TRUNK

PROJECT W210A-21

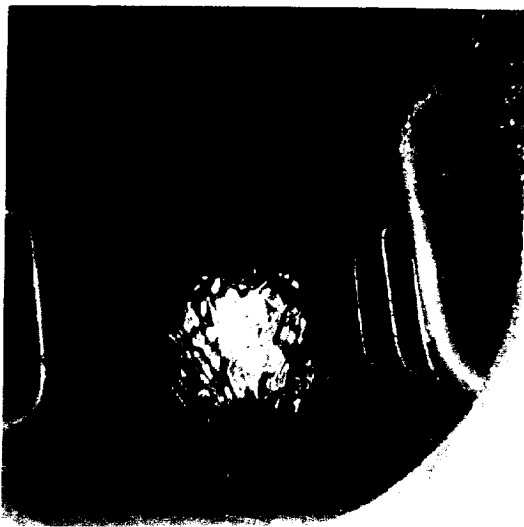
Upon uncapping it and going down in 4 or 5 feet, strong odors of a pungent gas was noticeable and had to come out to get the air equipment. Upon standing at the surface and then smelling slight wisps of it, it smells like gasoline or cigarette lighter fluid. This manhole is at the northeast corner, 15 feet out from the Northwest Glass Company office building. With the air equipment on, I went down and measured the invert grade from the top ring at 15.30 feet, observed the clay liner plates from the springline of the pipe over the crown on both sides. Invert clean, no sand and gravel, cannot hear any side sewers or flow coming in either to the north or south so cannot tell where this gasoline or cigarette lighter type smell is coming from. This manhole is right across from L. H. Butcher Company where there are hundreds of 50-gallon drums stacked in the yard - possible source of this pungent odor and gasoline type smelling fluid.

Photograph No. 62 - Looking down into manhole.

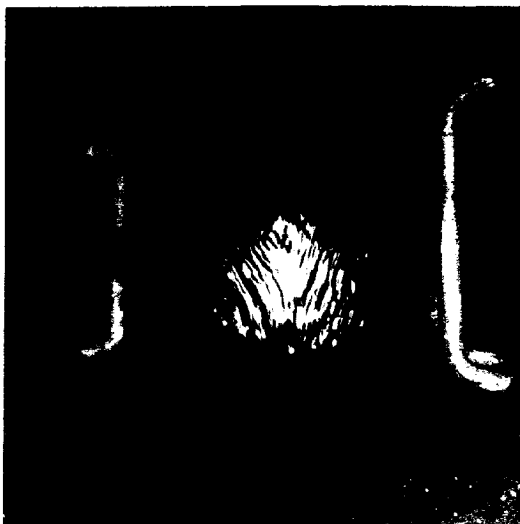
On the 60-inch line in a manhole directly east of the Brandon Street regulator structure. The 60-inch line is running with a fairly clean invert - quite a bit of smell at this point; have measured down from the rim 16.10 feet to the invert at the north side of the manhole. Condition of the manhole is good, the plastering is smooth, manhole steps are fairly tight, no apparent weeping or infiltration into the manhole. Manhole ring and cover need adjustment to a higher elevation so that storm inflow will not come in around the lid. Measured 3.40 feet from the crown of the 60-inch pipe down to the water surface, also measured back up from the water surface 5.8 feet to the highest water mark as identified by the debris on the steps on the side of the manhole.

Photograph No. 30 - Looking down into manhole.

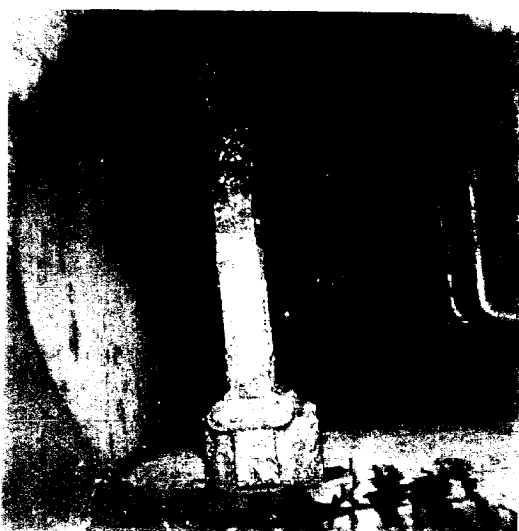
Photograph No. 29 - Looking down from the top - sheave, shaft and pillow block assembly on left.

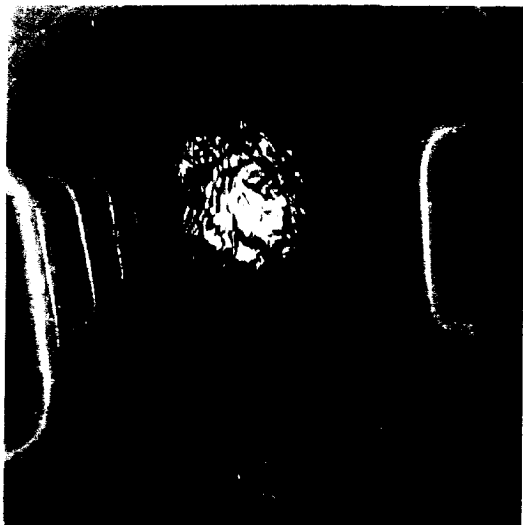
We are opposite the General Electric Company A & C sales at the 5,000 East Marginal Way block and opposite the water tower for the old Corps of Engineers building now being used by Boeing. In manhole No. 34, had the same gas conditions as they had in the previous manhole - scum, greases, petroleum products - on the bottom 2/3 of the way down in the manhole the steps are slick, fairly good galvanized manhole steps, however, the grease makes them very slippery. Also picked up a slight residue or scum sticking to the wall - it appears like the grease scum or cleaning solvent when it has been used in cleaning greasy clothes, etc. This scum is plastered over considerable area and could possibly be the source of some of these pungent smells that we are getting. The manhole in other respects is in good shape, the flow line is clean, no sands and gravels in the bottom, the ring is set firmly on top.

Photograph No. 64 - Looking down into manhole.
